Investigation of Deterioration of Joints in Concrete Pavements

National Concrete Pavement
Technology Center

Final Report
August 2012

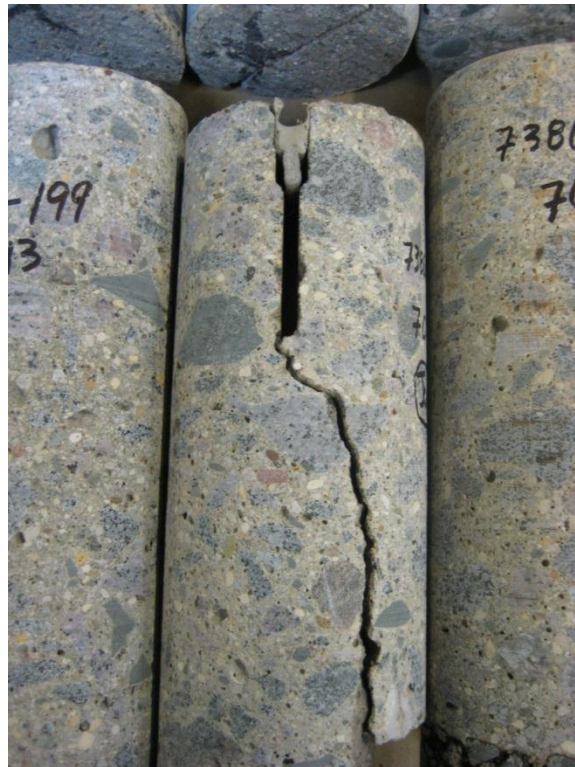
Figure 4. 7380 Core 7012

Two cores were taken from Route 94 near Brainerd. One, labeled 7009 (Figure 3), was selected as representing a distressed joint including a so-called tunnel at the bottom of the joint, while the other, labeled 7012, appeared to be in better condition (Figure 4).

- The silicone sealant was de-bonded from the concrete in core 7009 but bonded in core 7012
- Both joints were cracked out
- Damage typical of freeze-thaw distress was extensive in Core 7009 and no damage was observed in Core 7012
- Both cores exhibit air voids filled with ettringite but the extent is greater in Core 7009
- Carbonation is slightly deeper in Core 7012 than Core 7009
- The air void parameters are shown in Table 1
- Both samples contained 15-25% fly ash
- Top surface of both cores was in good condition

7. Core "7012" was centered and taken directly through a silicone sealed (with backer rod), sawcut control joint. The top surface of the core exhibited minor mortar erosion. The silicone sealant was well bonded to both sides of the joint and the sawcuts were in relatively pristine condition; apart from "rounding" and wear of the top surface edges. The silicone sealant exhibits good bond and contact along its entire thickness. No distress was observed along the entire depth of the joint. the concrete was purposefully air entrained and exhibits high quality parameters for freeze-thaw resistance under severe exposure conditions. Secondary ettringite does fill some of the smaller entrained sized voidspaces within 3mm of the joint crack plane and within several millimeters of the base of the pilot sawcut.

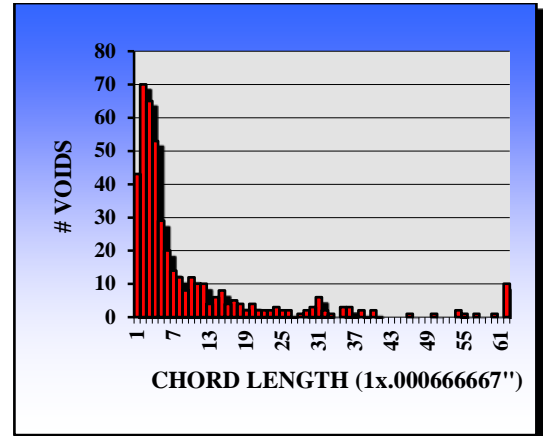
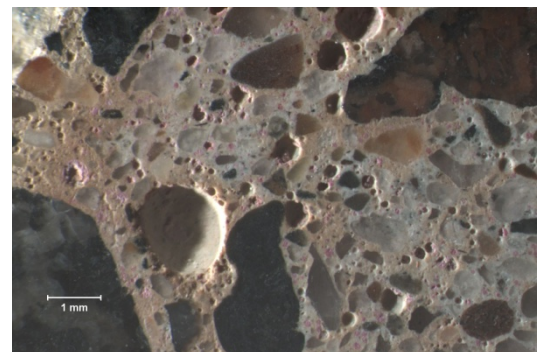
Test Data: By ASTM C:457
Air Void Content % 8.3
Entrained, % < 0.040"(1mm) 4.8
Entrapped, % > 0.040"(1mm) 3.5
Air Voids/inch 8.8
Specific Surface, in²/in³ 420
Spacing Factor, inches 0.007
Paste Content, % estimated 26
Magnification 75x
Traverse Length, inches 50
Test Date 1/31/2012

Description: Hardened air void system 150mm from the top surface and at the joint crack.

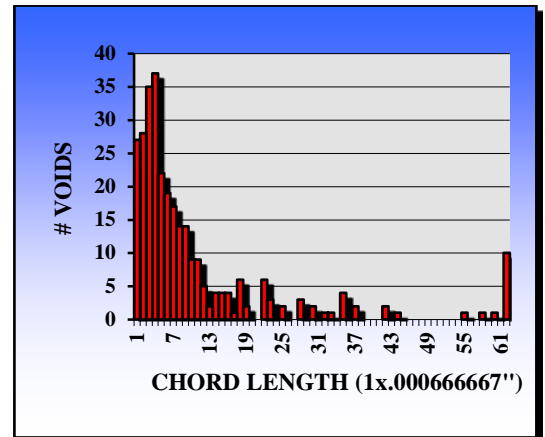
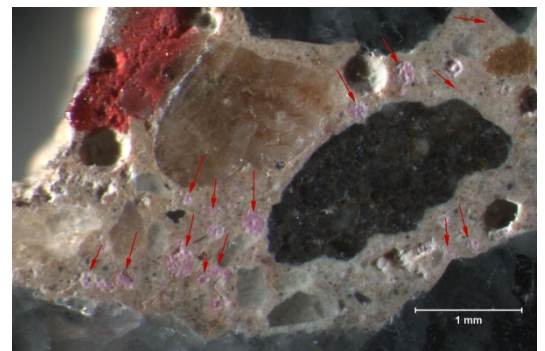
Air Void Content %	4.9
Entrained, % < 0.040"(1mm)	3.4
Entrapped, % > 0.040"(1mm)	1.5
Air Voids/inch	6.10
Specific Surface, in ² /in ³	500
Spacing Factor, inches	0.010
Paste Content, % estimated	26
Magnification	75x
Traverse Length, inches	49
Test Date	2/29/12

Description: Hardened air void system 70mm from top; 0mm from joint.

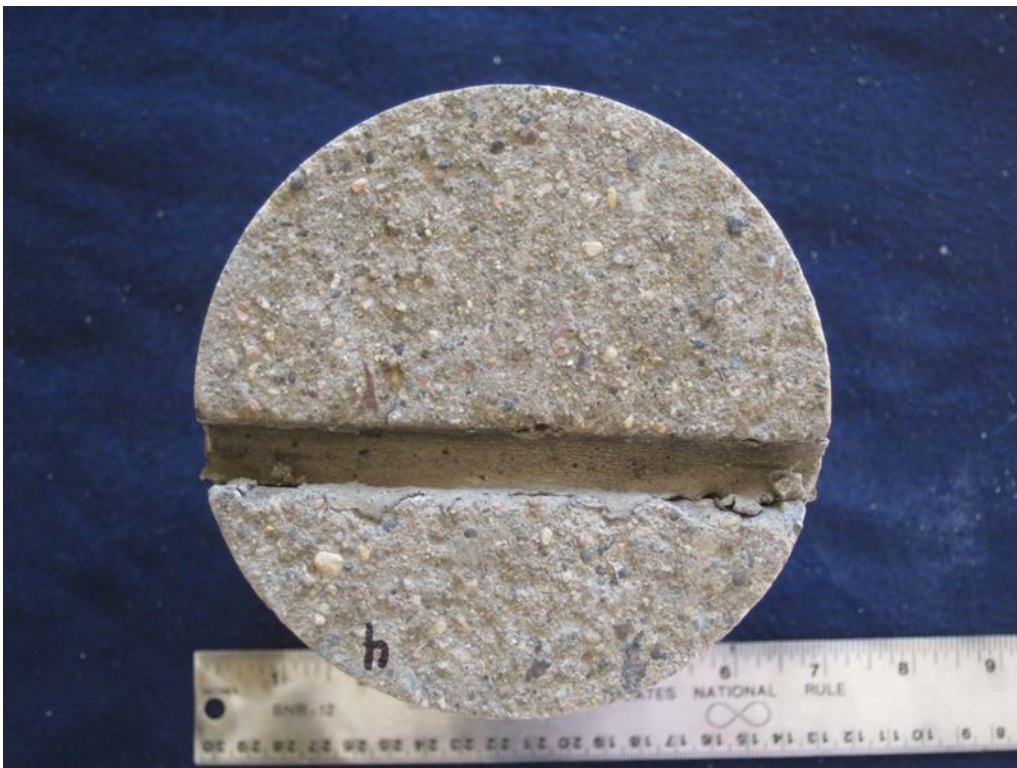
PHOTO: 3

SAMPLE ID: 4, 4705-30 **DESCRIPTION:** Top surface of the core as received. Note core was taken through a sawcut and silicone sealed control joint.

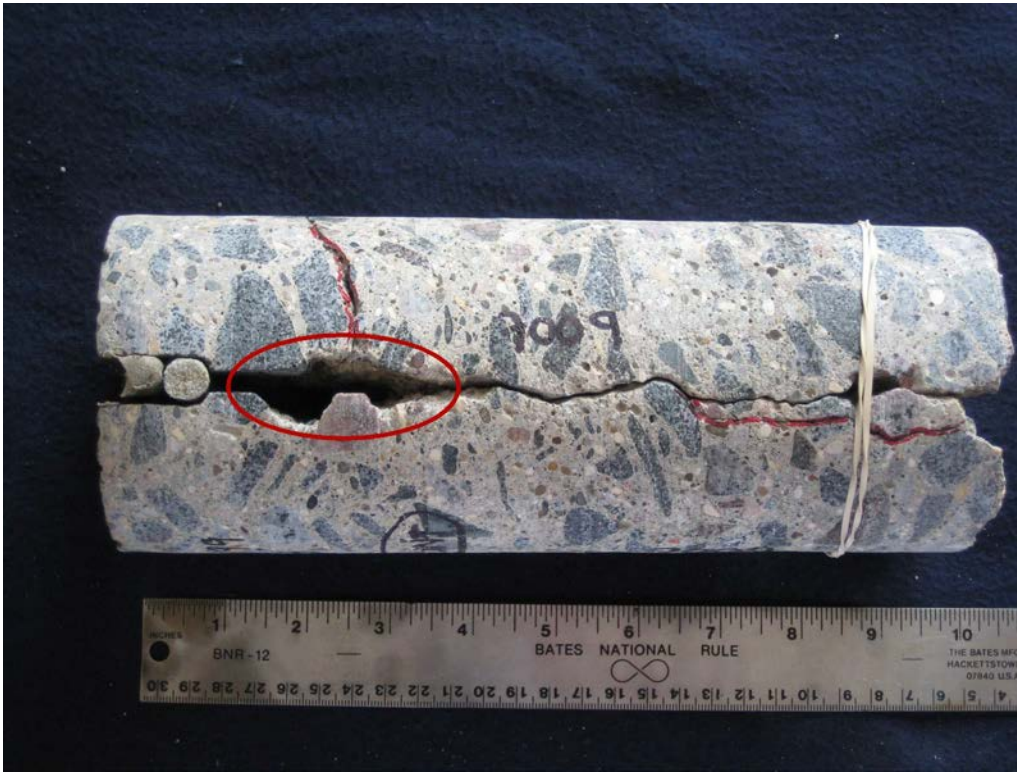
PHOTO: 6

6. Core "7009" was centered and taken directly through a silicone sealed (with backer rod), sawcut control joint. The top surface of the core exhibited minor mortar erosion. The silicone sealant was completely de-bonded from one side of the joint and the sawcuts were in relatively pristine condition; apart from "rounding" and wear of the top surface edges. In general, apart from the very thin top few millimeters (meniscus) of the silicone, the joint sealant was "cleanly" de-bonded from the one side of the sawcut and the vertical surface of the sealant in contact with the concrete are darkly stained. The distress in core "7009" was characterized chiefly by "tunneling"; an oval shaped loss of paste to 22mm in width between approx. the base of the reservoir sawcut and approx. 90mm depth in the core. Significant incipient distress (sub-vertical microcracking) was observed on both sides of the joint crack to 20mm depth laterally and between 120mm depth and the bottom surface of the core. Measured "existing" air void parameters in the 0 to 25mm of the paste directly adjacent to the joint crack and in the lower half of the core are poor and include a loss of 1.5% entrained sized air void volume and a spacing factor which rose from 0.006" to 0.010".

SAMPLE ID: 7009, 7380-199

DESCRIPTION: Core sample taken directly through a pavement joint, as received. Top surface is left. Note "tunneling" below the sawcut (circled).

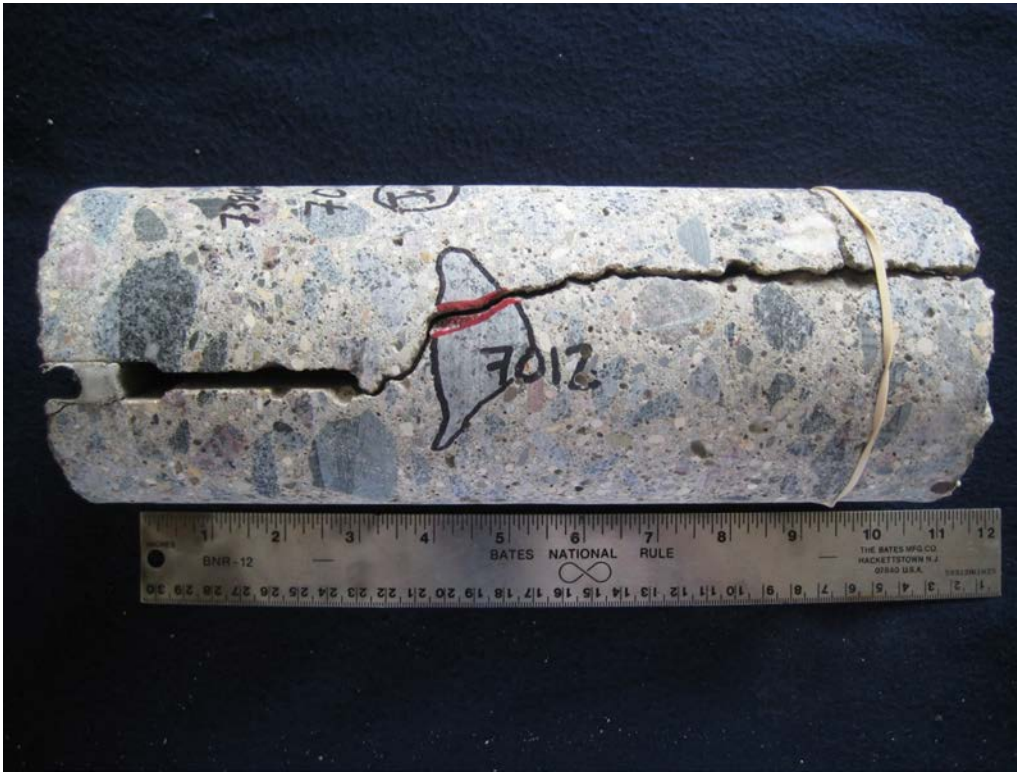
PHOTO: 8

SAMPLE ID: 7012, 7380-199

DESCRIPTION: Core sample taken directly through a pavement joint, as received. Top surface is left. Note joint crack bisects a large coarse aggregate particle (outlined in black).

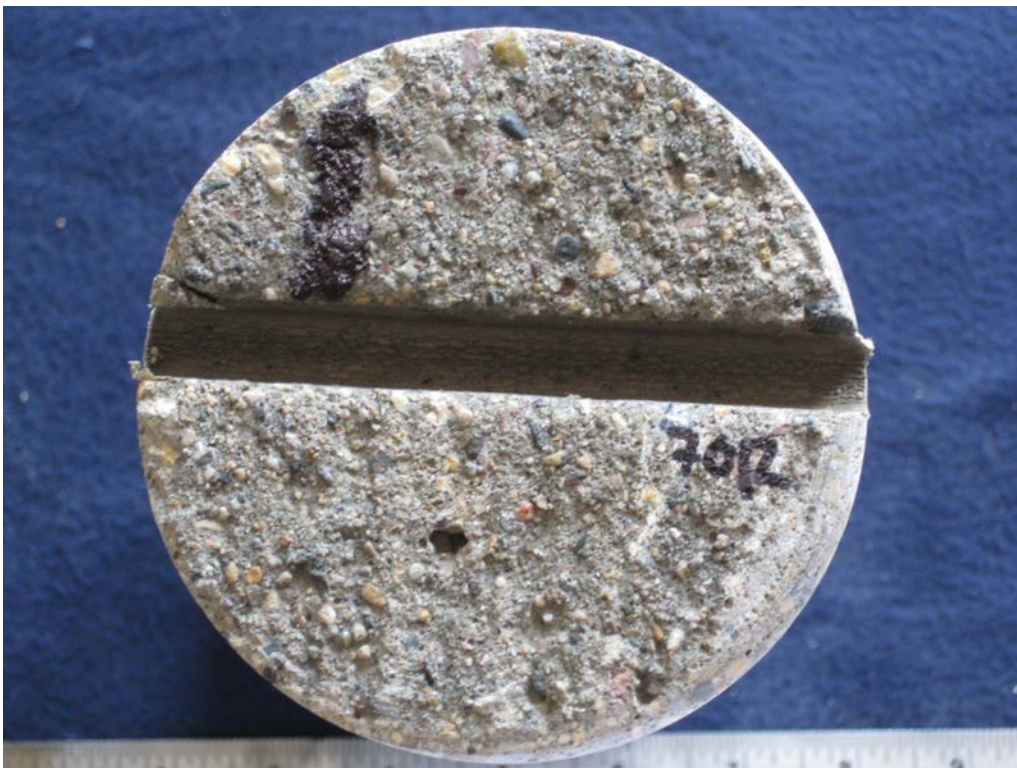
SAMPLE ID: 7012, 7380-199

DESCRIPTION: Mortar-eroded top surface of the core as received. Note core was taken through a sawcut and silicone sealed control joint.

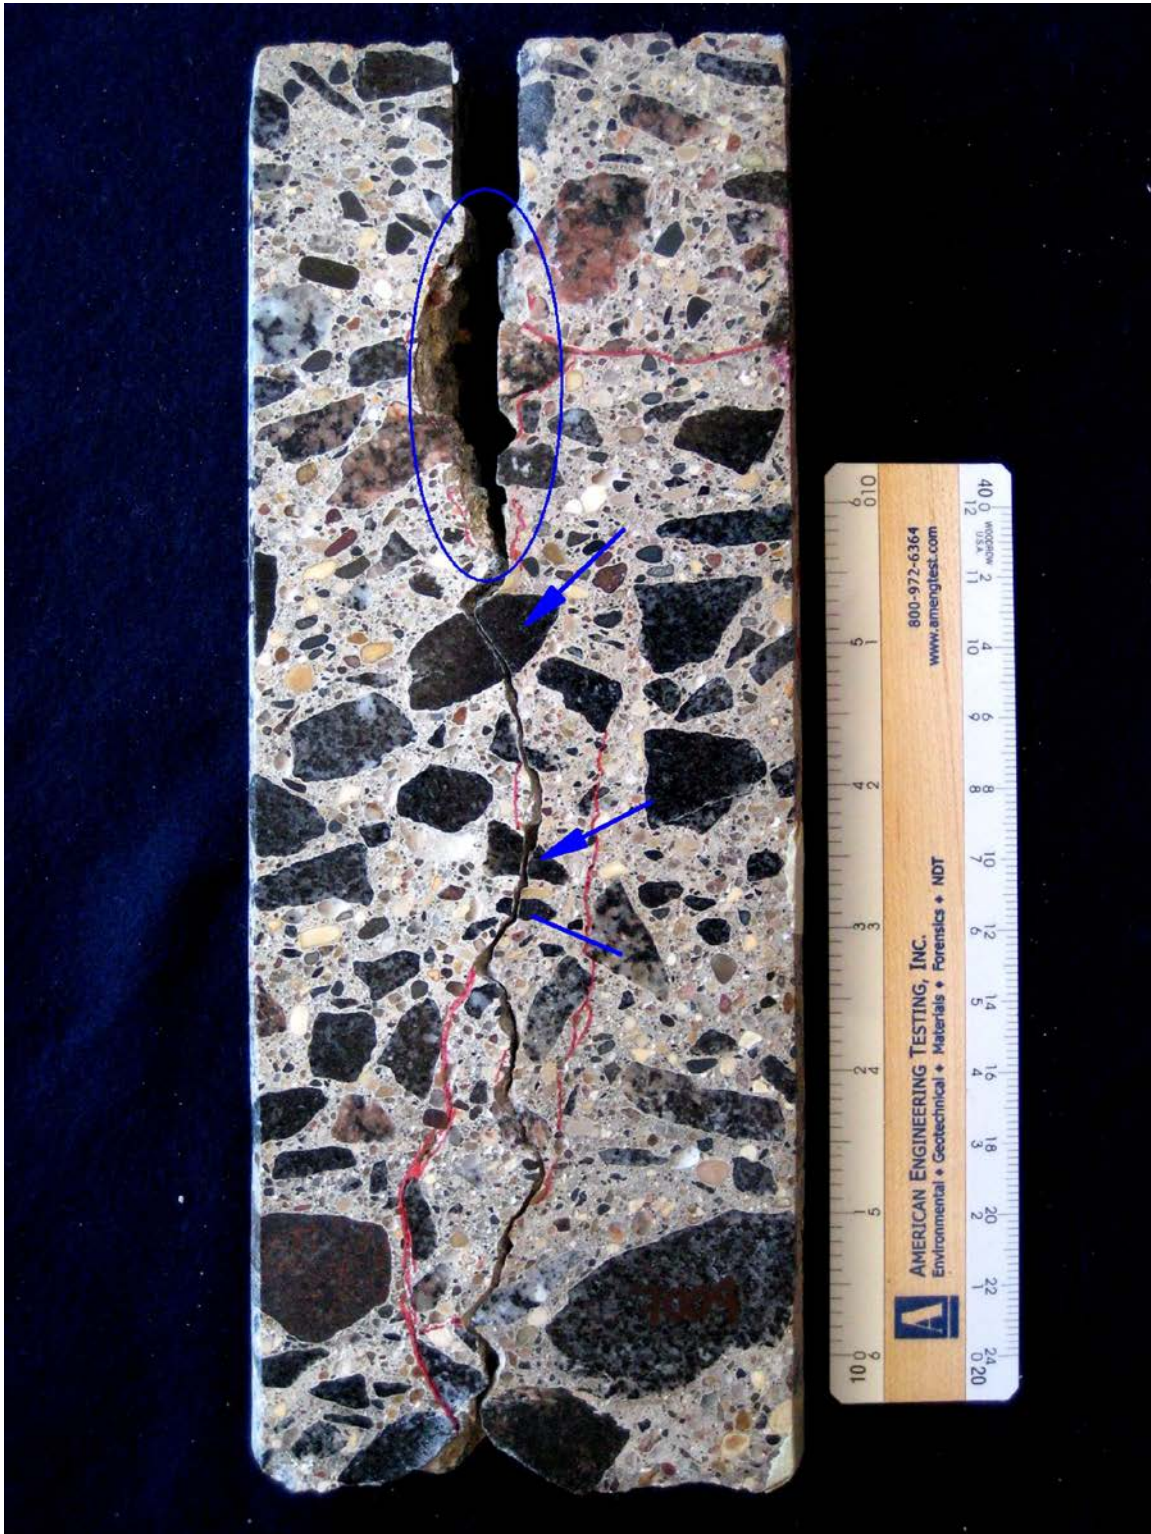
PHOTO: 12

SAMPLE ID: 7009, 7380-199

DESCRIPTION: Sawcut and lapped cross section of core. Note "tunneling" below the sawcut (circled), bisected coarse aggregates (arrows), and sub-vertical microcracking along the joint crack, mapped in red ink.

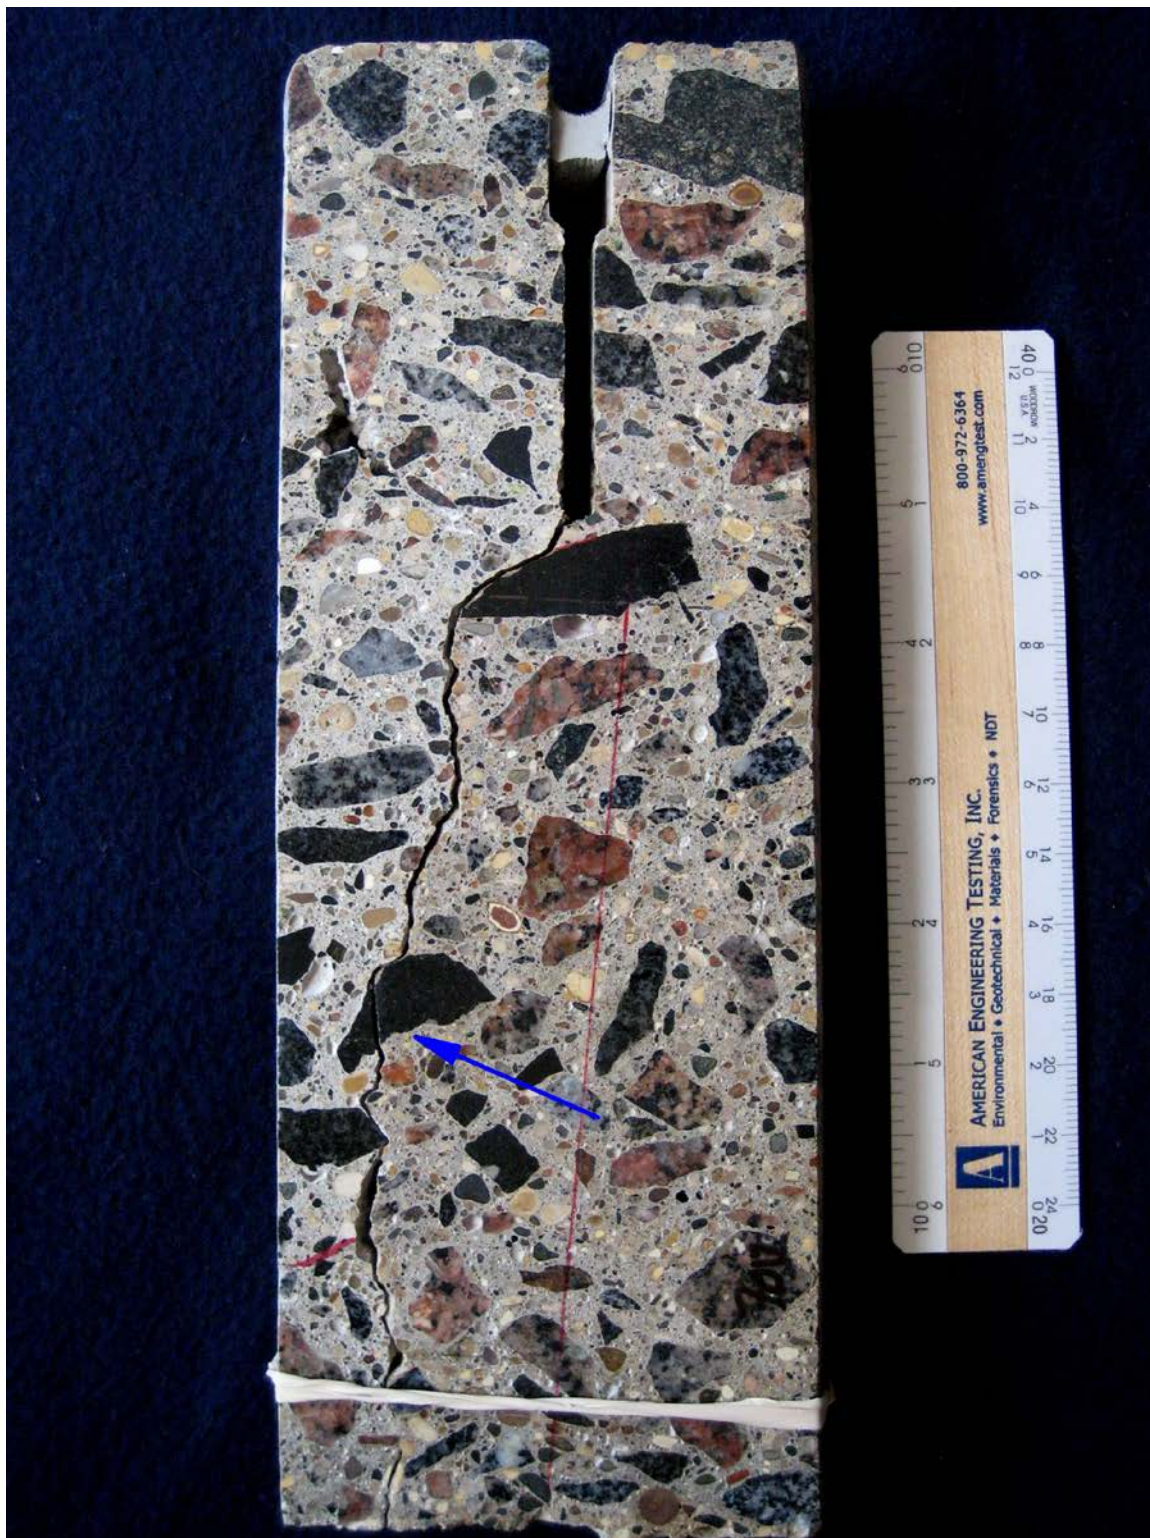
PHOTO: 13

SAMPLE ID: 7012, 7380-199

DESCRIPTION: Sawcut and lapped cross section of core taken through a joint. Note resulting crack bisects a coarse aggregate (arrow).

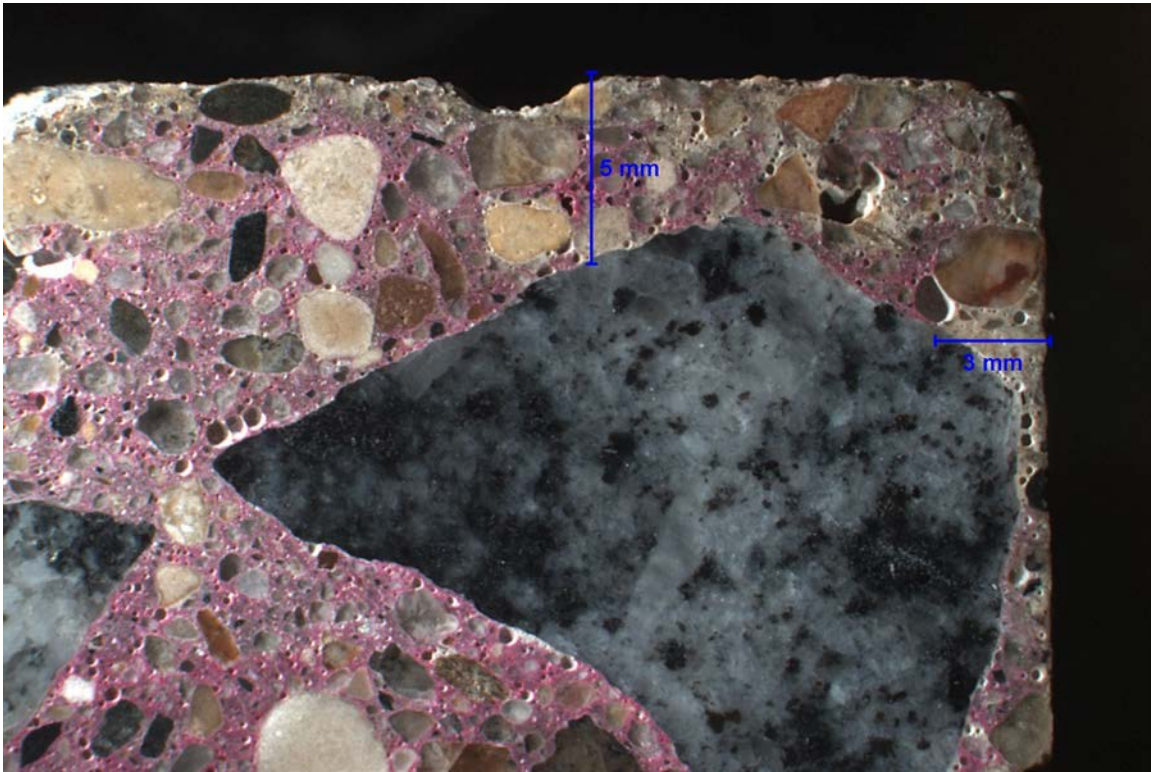
PHOTO: 14

SAMPLE ID: 4, 4705-30 **DESCRIPTION:** Carbonation (unstained) proceeds up to 5mm depth from the top surface and up to 3mm depth from the sawcut joint surface; in this view of sawcut and lapped cross section of core exposed to phenolphthalein pH indicator.

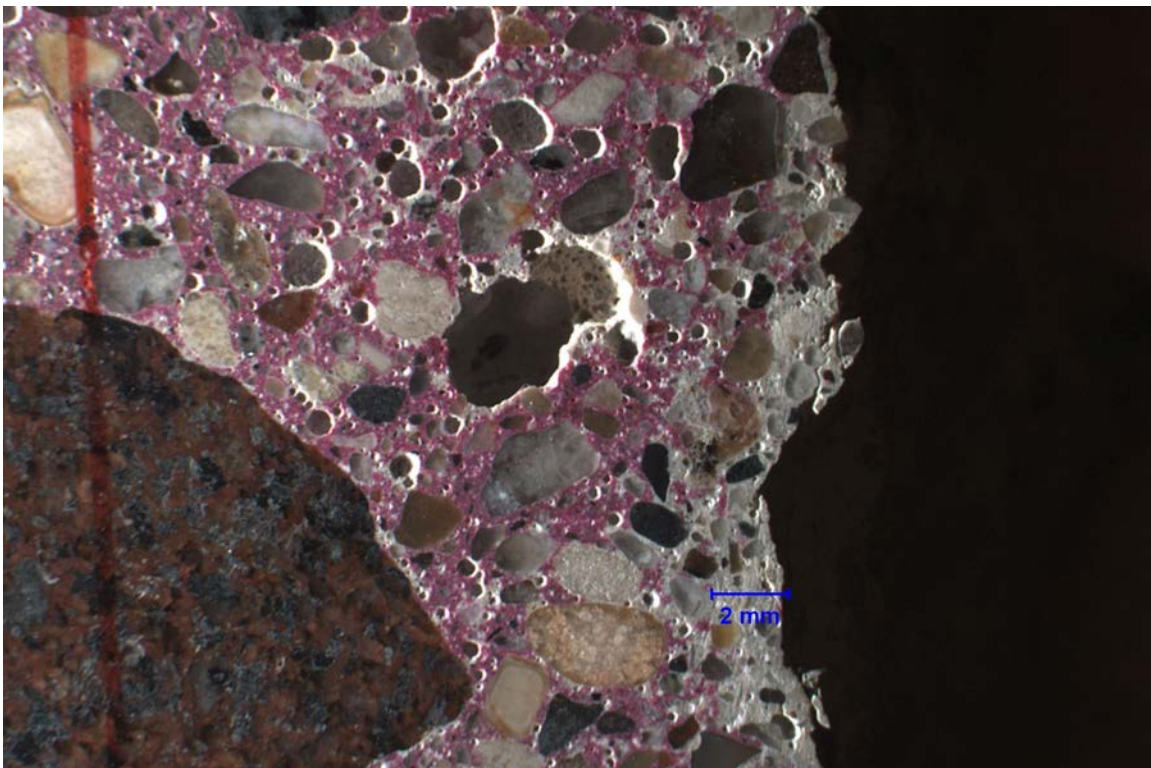
SAMPLE ID: 4, 4705-30 **DESCRIPTION:** Carbonation (unstained paste) proceeds up to 2mm depth from the distressed joint plane at 100mm depth in the core.

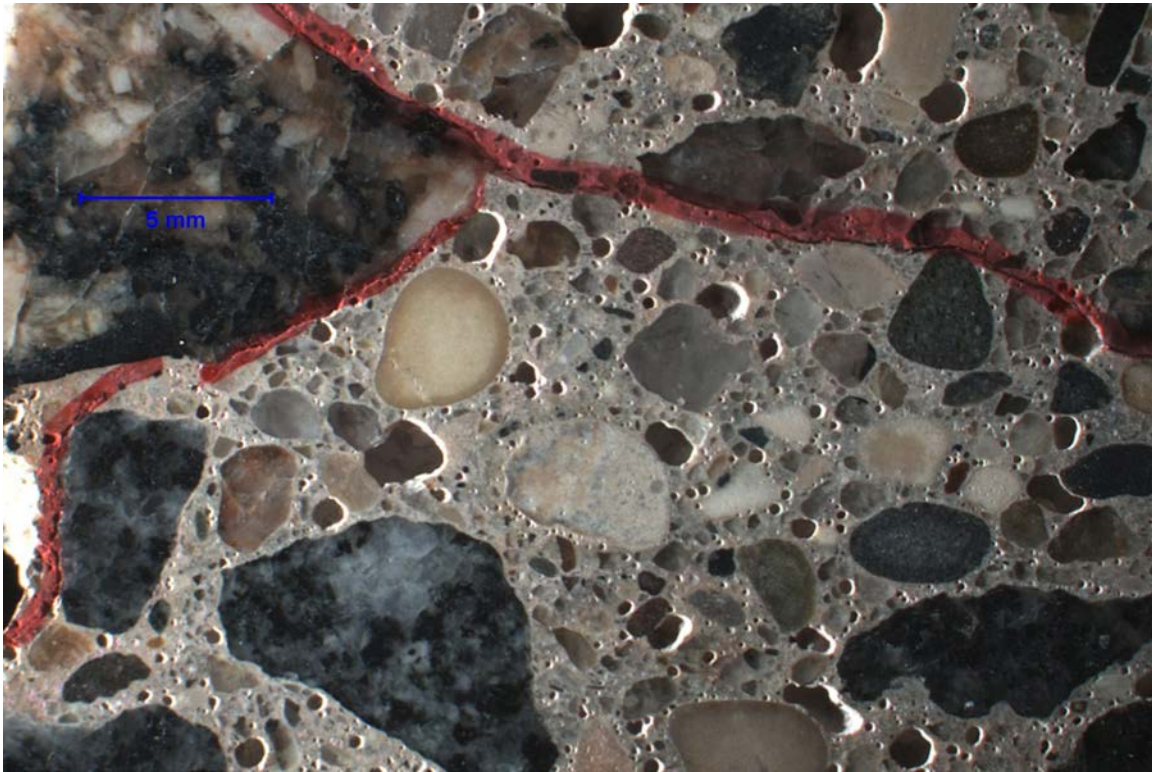
PHOTO: 15

DESCRIPTION: Overall view of air void system at 60mm depth in the core. Not loss of fine air voidspaces on left 1/3 of image from secondary ettringite fillings.

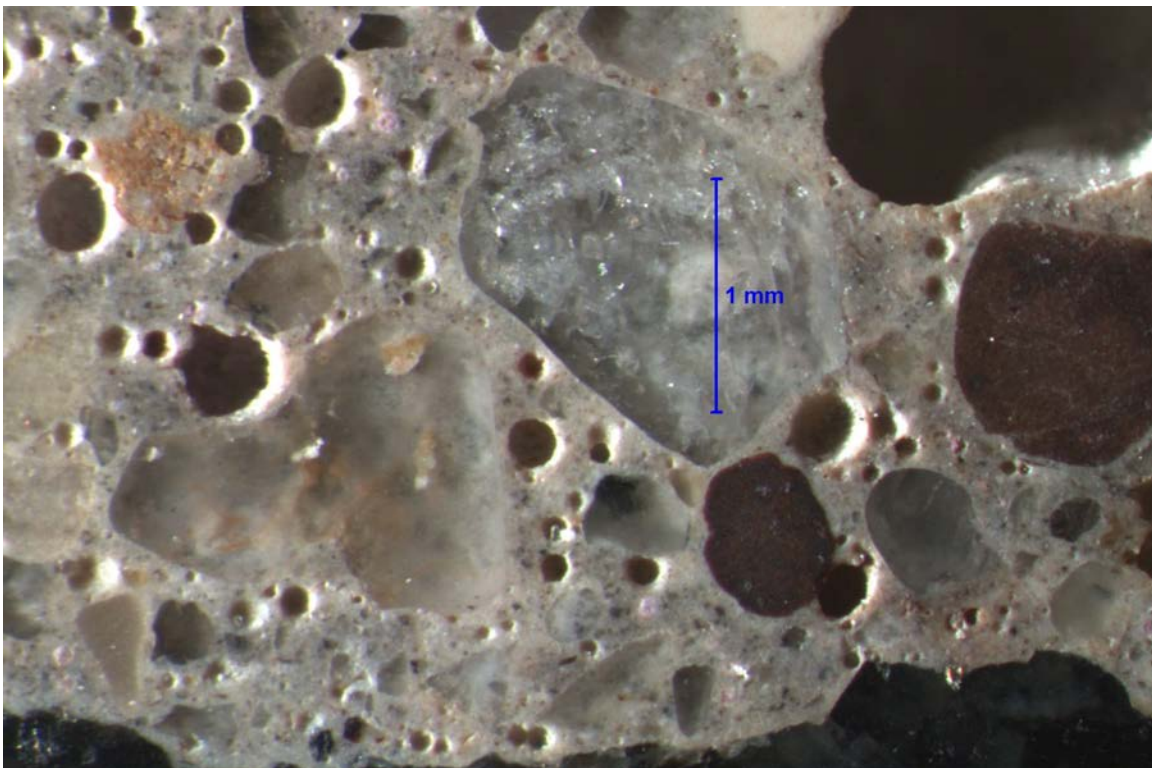
PHOTO: 16

DESCRIPTION: Air void system at 70mm depth in the core and 45mm depth from the distressed joint plane.

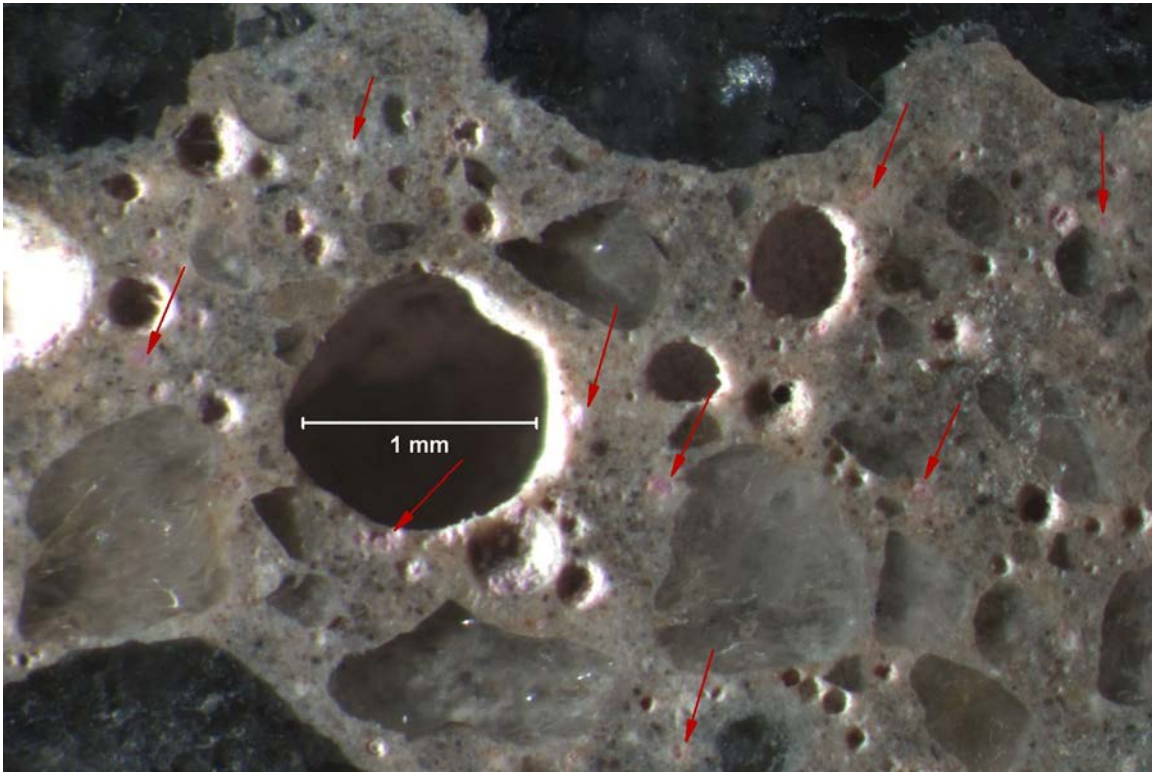
PHOTO: 17

DESCRIPTION: Overall view of air void system at 70mm depth in the core and 25mm from the distressed joint plane. Note (stained) ettringite-filled air voidspaces (arrows).

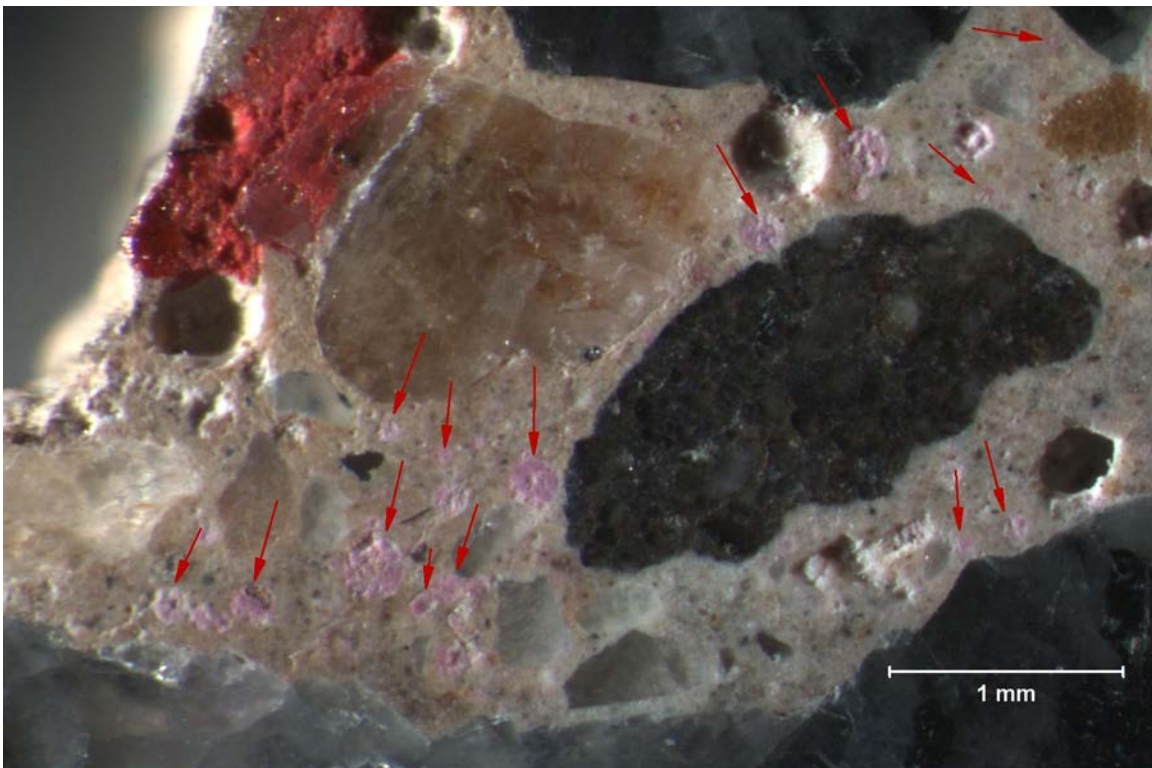
PHOTO: 18

DESCRIPTION: Air void system at 70mm depth in the core and at the distressed joint plane (L). Note stained ettringite-filled voidspaces marked with arrows.

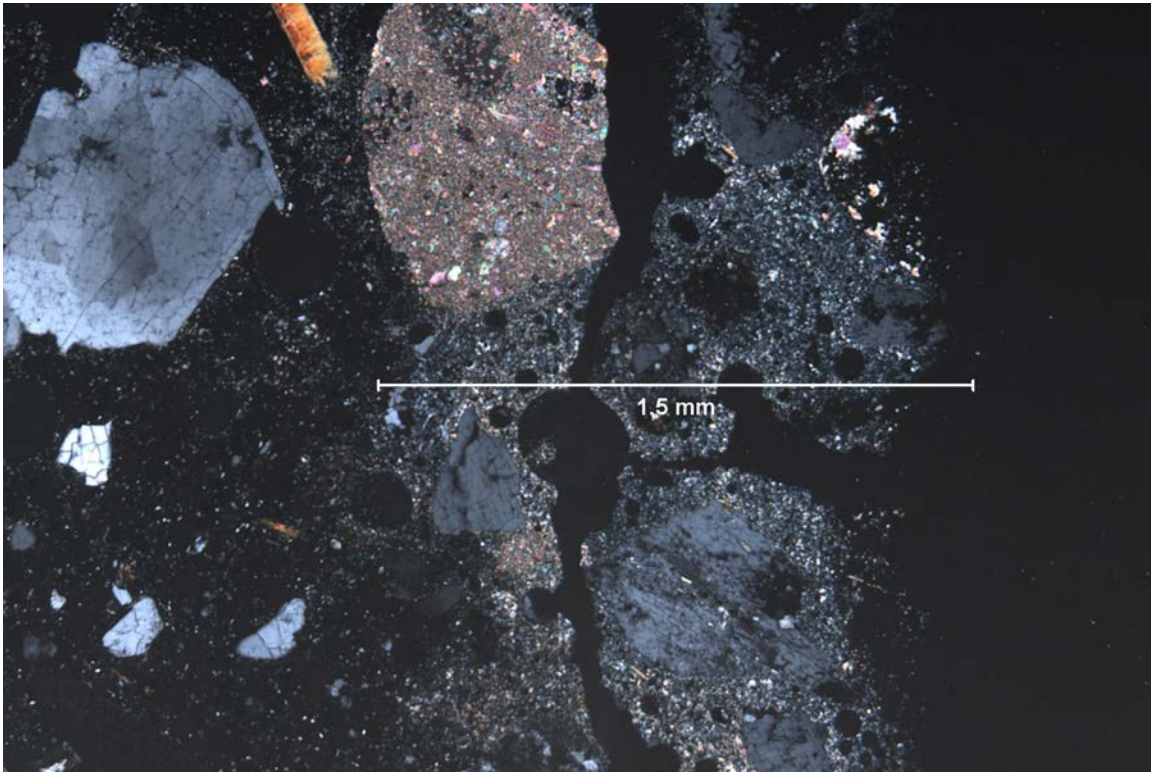
PHOTO: 19

DESCRIPTION: Overall view of brightly colored carbonated paste to 1.5mm depth from the distressed joint plane; in thin section of concrete under cross polarized light.

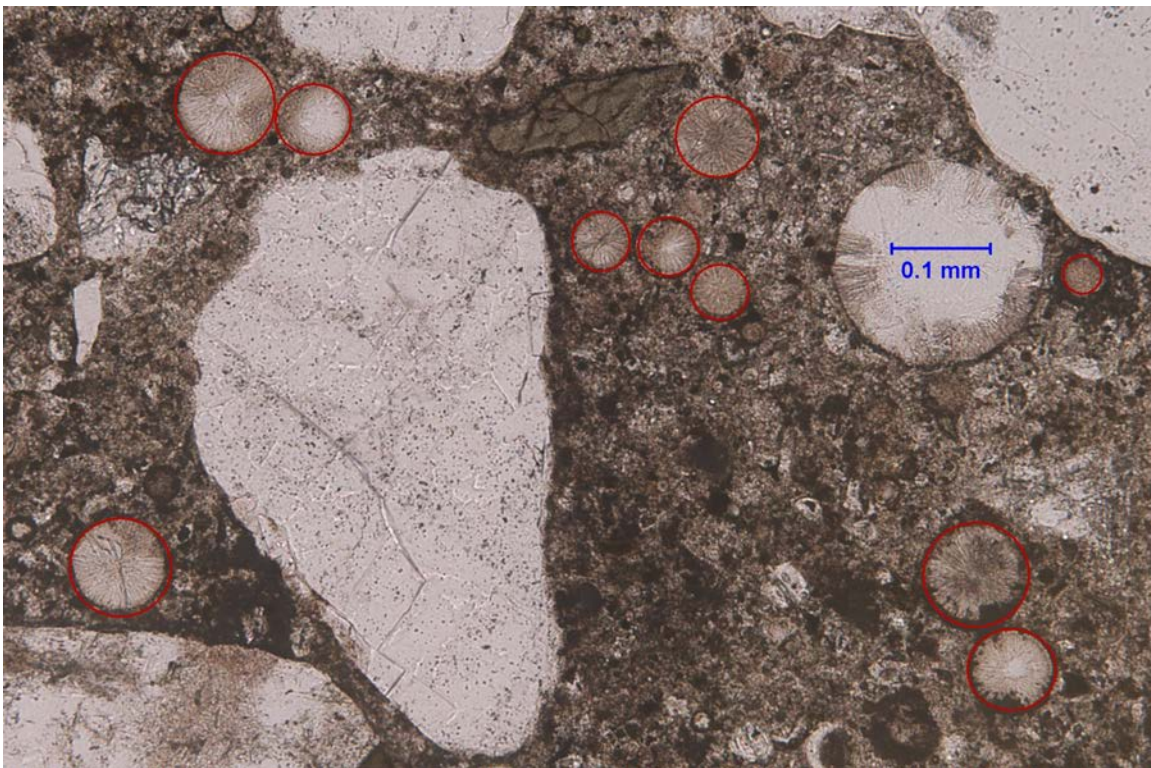
PHOTO: 20

DESCRIPTION: Ettringite-filled voidspaces, outlined in red, in thin section of concrete paste adjacent to the distressed joint plane, under plane polarized light.

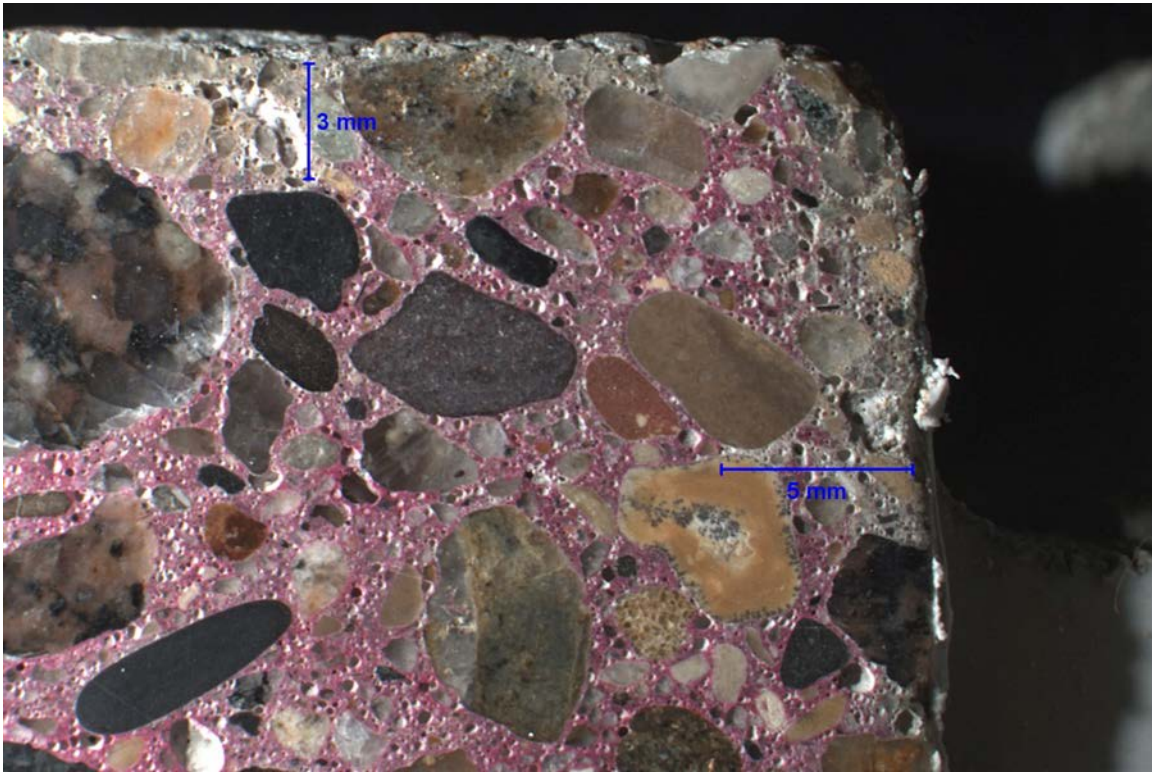
PHOTO: 21

DESCRIPTION: Carbonation (unstained) ranged from negligible up to 3mm depth from the top surface and ranged from negligible up to 5mm depth from the sawcut joint surface; in this view of sawcut and lapped cross section of core exposed to phenolphthalien pH indicator.

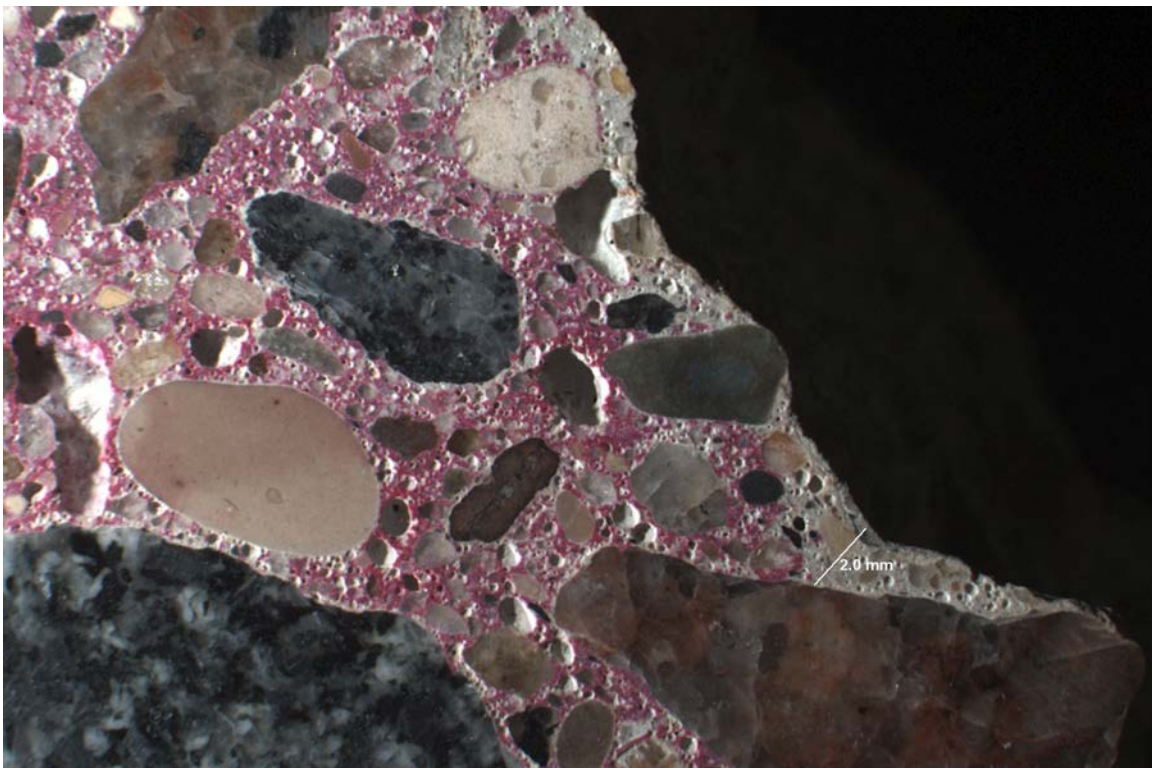
PHOTO: 22

DESCRIPTION: Carbonation (unstained paste) proceeds up to 2mm depth from the stressed joint plane at 105mm depth in the core.

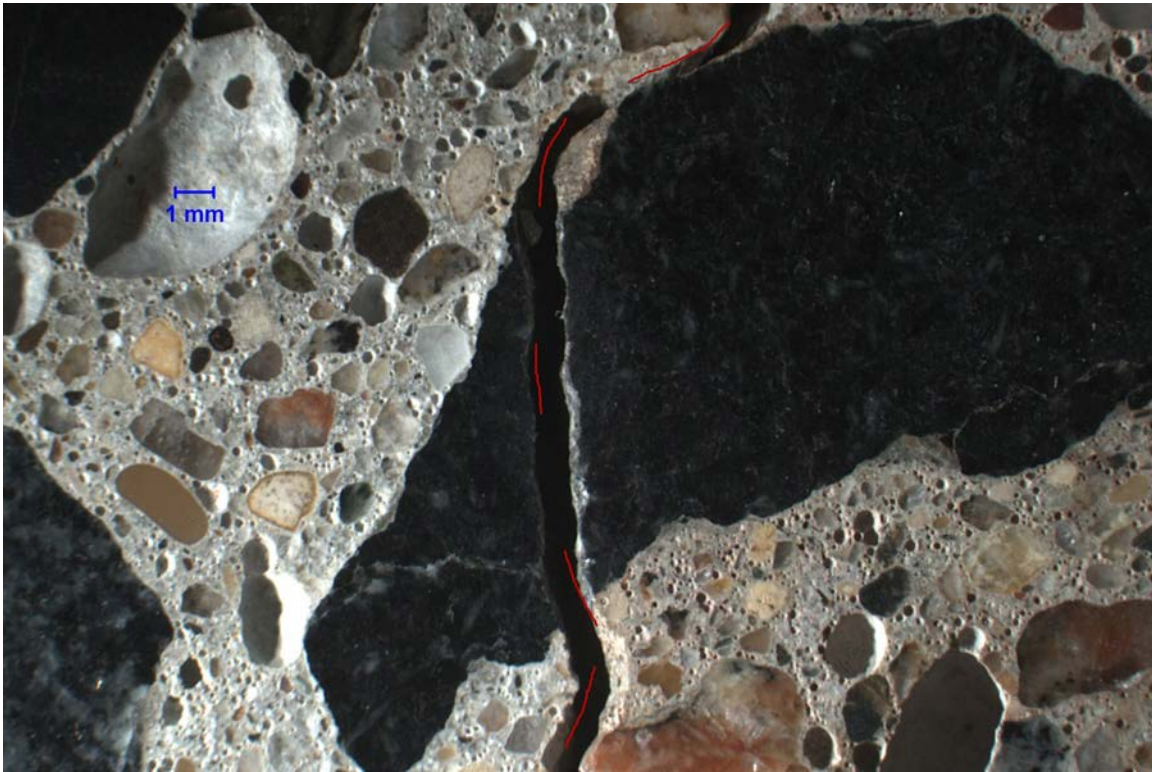
PHOTO: 23

DESCRIPTION: Cracked coarse aggregate at 165mm depth in the joint crack.

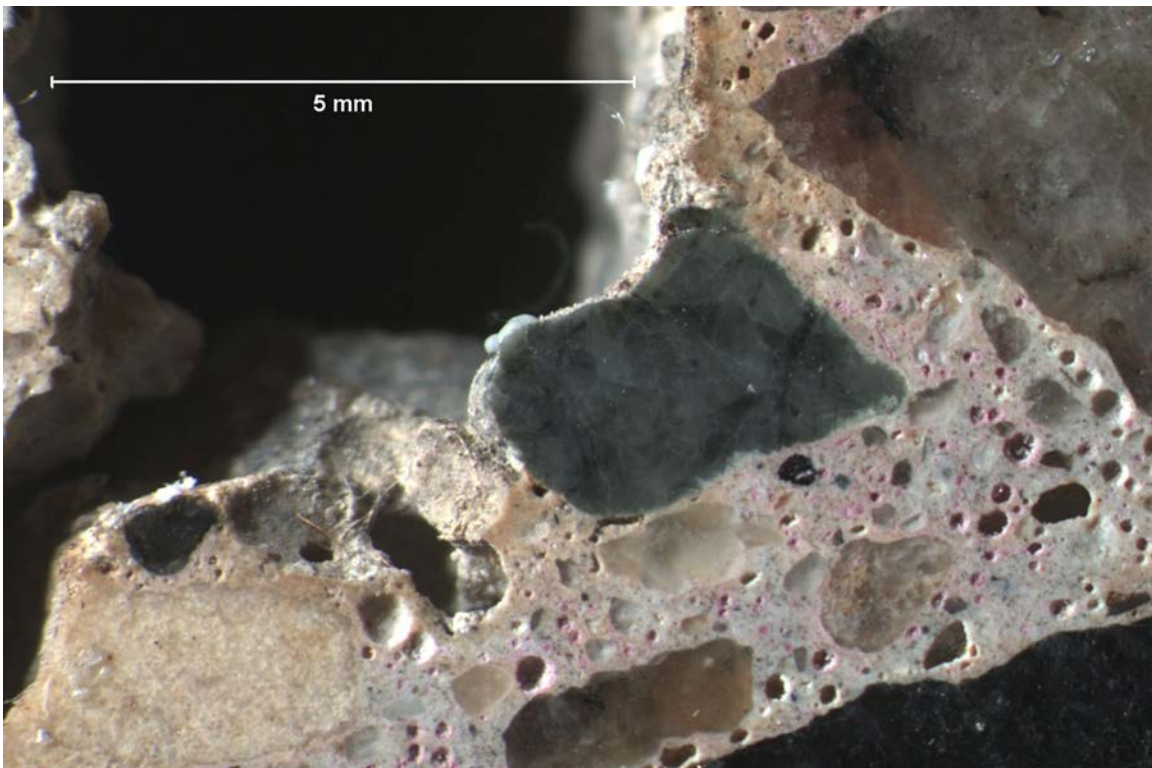
PHOTO: 24

DESCRIPTION: A concentration of magenta-stained, ettringite-filled voidspaces at the base of the sawcut control joint.

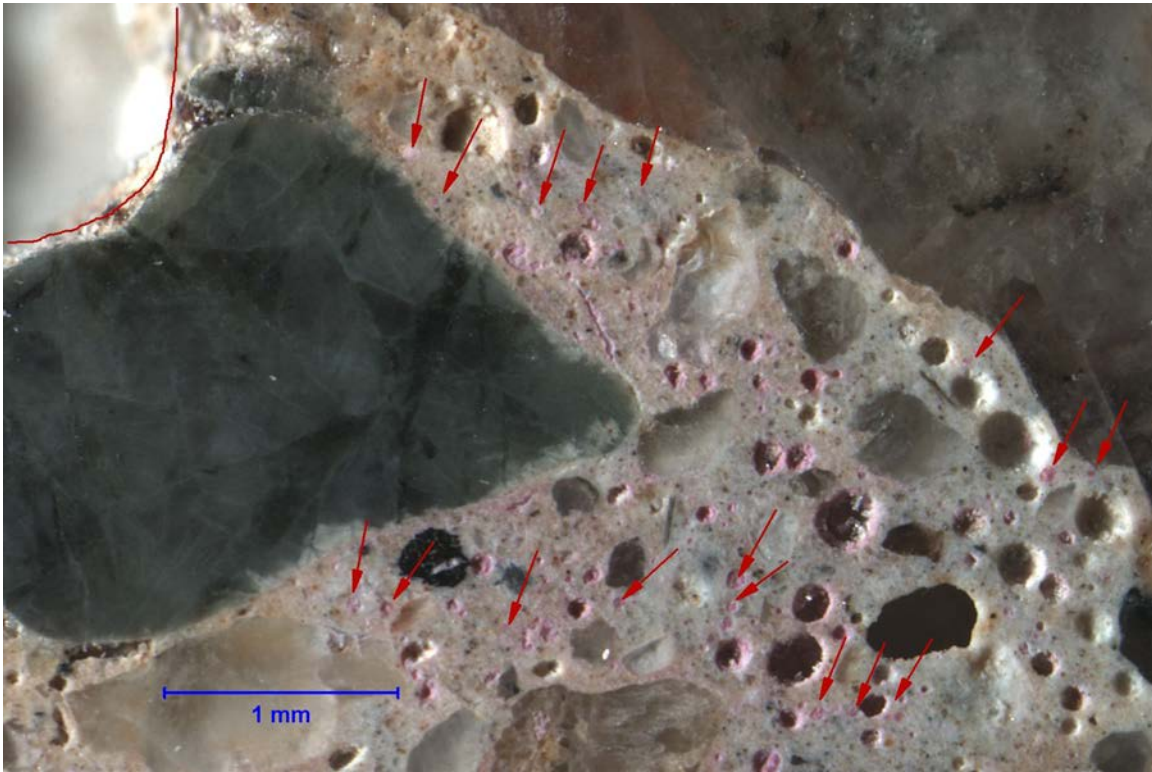
PHOTO: 25

DESCRIPTION: Closer view of fine, ettringite-filled voids at the base of the sawcut.

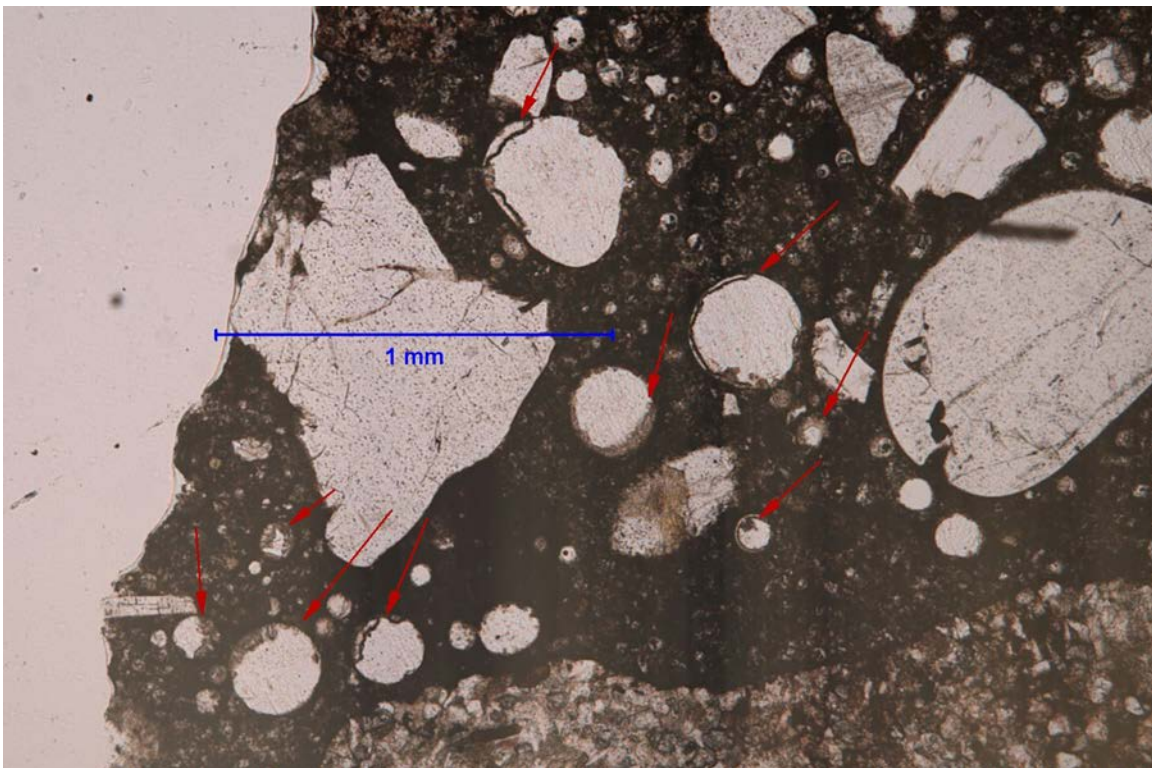
PHOTO: 26

DESCRIPTION: Occurrences of ettringite on the linings of voidspaces at 140mm depth and directly adjacent to the joint crack (L).
